Failure Analysis of Heat Exchanger Tubes at Different Operational Conditions

Irfan Ullah¹, Muhammad Yousuf²

Abstract— Heat exchanger tubes generally deteriorate or corrode as a result of their susceptibility to a wide range of tube and shell mediums under varying working conditions. The current study aimed to conduct a failure analysis of heat exchangers in the Petrochemical Industries under various operating conditions. According to kinetic and thermal analysis, heat exchanger tubes corroded primarily as a result of the carbon dioxide (CO₂) solute in crude oil passing through the tubes, causing electrochemical corrosion. Polarized tests were carried out to analyze the outer surface cavities produced on the tubes. Tests revealed that CO₂ had no substantial association with cavities on the surface of the tube. Additionally, microstructural analysis of corroded heat exchanger's tubes demonstrated that solid suspended particles of high hardness present in crude oil or methanol detached from previous phase catalysis causing electrochemical as well as the erosion-corrosion mechanism inside and outside heat exchanger tubes. Appropriate methods for prevention or mitigation of tubes corr

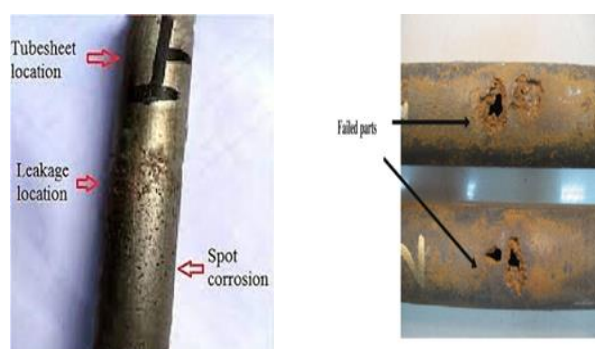
Figure 1. Heat Exchanger corroded tubes

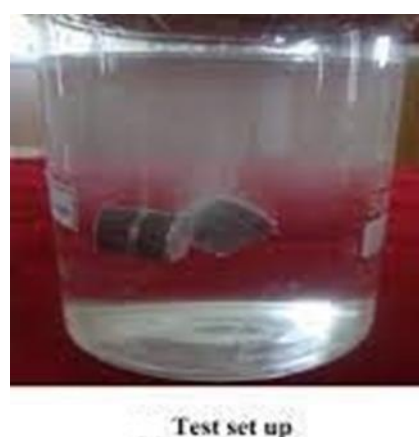
Figure 2. Immersion test for corroded tubes sample with methanol

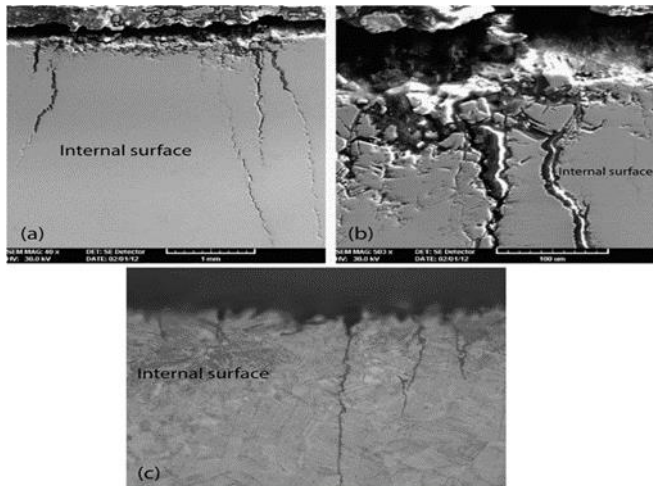
Define Scanning electron microscopy images demonstrate the sample tube corrosion in Figures 2a, 2b, and 2c. The tube out surface looks like a regular pattern gear wheel and reduced thickness can be clearly seen in specified regions. The curved cavities formation on tube surface (2b) attributed to erosion-corrosion phenomenon. Additionally, accelerated under-deposited corrosion is caused by corrosion of the tube's outer surface. The spherical morphology of shell deposited corrosion is clear. It might be either caused by solid pollutant particles in crude methanol or products of detached corrosion. Also, sharp edges elimination on SEM image demonstrated the erosion phenomenon. X-rays fluorescence spectroscopy (XRF) and Energy dispersive spectroscopy (EDS) were performed for composition and deposited elements determination respectively. The deposited layer on the heat exchanger tubes was Fe, C, and O as shown in Figure 3. The composition of heat exchanger tubes before and after corrosion are shown in Table 2. The carbon contents increased from the original sample 0.06 wt% to 6 wt% on the corroded sample whereas oxygen was absenting the original sample but appeared in the corroded sample. The percentage loss of C, O, and Fe is actually the carbon steel sample corrosion. In short, iron oxide sand carbonate are the possible combinations that cause heat exchanger tube corrosion. Moreover, the iron carbonate was present in higher quantity compared to iron oxide which may conclude that iron oxide at the beginning was converted into carbonate due to crude methanol passage with CO₂ through tubes.

SEM outcomes revealed that the cavities formed depth are almost equal or about to the mouth size, ruling out the pitting corrosion possibility [27]. Cavitation due to CO₂ low vapor pressure at crude methanol average temperature of, i.e. 53 C, might be another possibilities. Producing holes seen on the tube is incapable [28]. The third possibility is Fe and Cu galvanic coupling. As per XRD analysis, Cu exists in the form of oxide and carbonate, not as a metal form capable of electrical contact. Furthermore, the Cu formation in corrosion deposits caused by galvanic coupling.

Figure 3. Scanning Electron Microscopy of Corroded heat exchanger tubes a) internal surface cracks, b) internal stress cracks, and c) erosion-corrosion

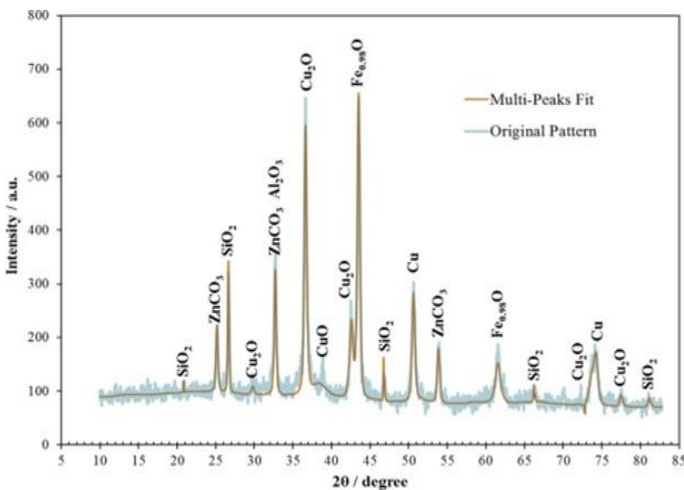
The heat exchanger tubes deposited layer was analyzed using EDS-XRD where spectrum of various compound such as SiO₂, ZnCO₃, CuO, Fe₂O, Cu₂O, and Al₂O₃ were seen on the corroded sample. Abrasive particles include silica, alumina, and carbonate. These particles, depending on fluid motion types and flow intensity, can cause a significant surge in mechanical degradation influencing erosion-corrosion [16]. Moreover, with spontaneous reaction electrochemical corrosion rate enhanced with crude methanol substituted copper particles [17, 18].

Figure 4. EDS-XRD of Corroded sample
